Contract #: 04-0120F4Cty: SF/ALA Rte: 80 PM: 13.2/13.9File #: 69.28**WELDING INSPECTION REPORT****Resident Engineer:** Pursell, Gary**Address:** 333 Burma Road**City:** Oakland, CA 94607**Report No:** WIR-017090**Date Inspected:** 21-Aug-2010**Project Name:** SAS Superstructure**OSM Arrival Time:** 700**Prime Contractor:** American Bridge/Fluor Enterprises, a JV**OSM Departure Time:** 1900**Contractor:** Zhenhua Port Machinery Company, Ltd (ZPMC), Changxing Island **Location:** Shanghai, China**CWI Name:** Xu Tao**CWI Present:** Yes No**Inspected CWI report:** Yes No N/A**Rod Oven in Use:** Yes No N/A**Electrode to specification:** Yes No N/A**Weld Procedures Followed:** Yes No N/A**Qualified Welders:** Yes No N/A**Verified Joint Fit-up:** Yes No N/A**Approved Drawings:** Yes No N/A**Approved WPS:** Yes No N/A**Delayed / Cancelled:** Yes No N/A**Bridge No:** 34-0006**Component:** OBG COMPONENT**Summary of Items Observed:**

WELDING INSPECTION REPORT

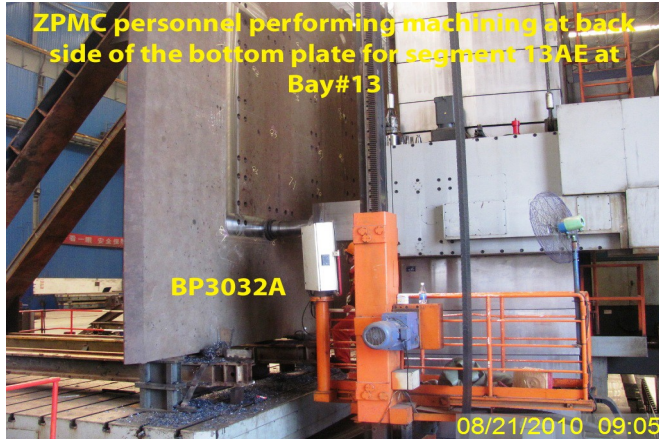
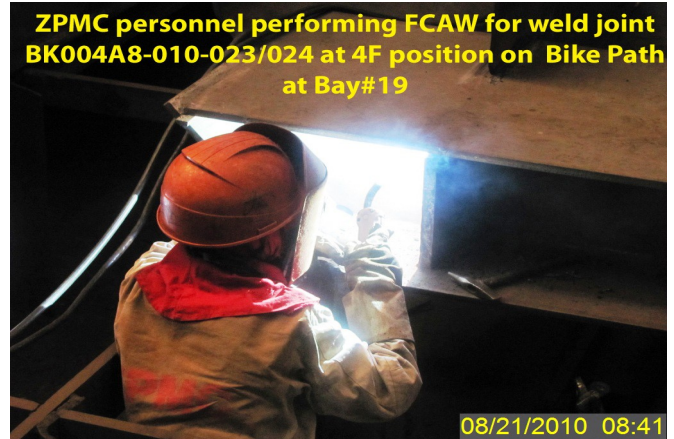
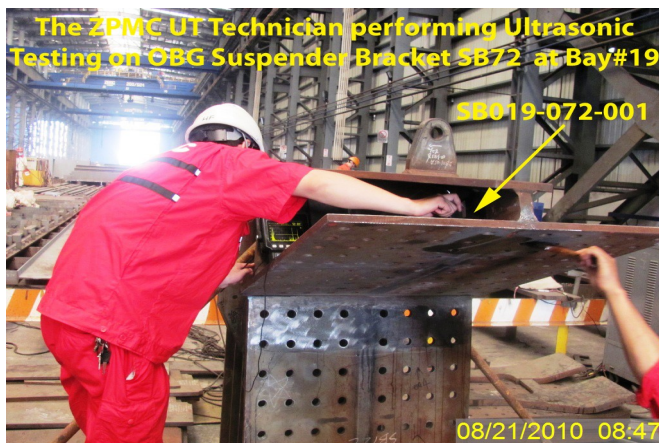
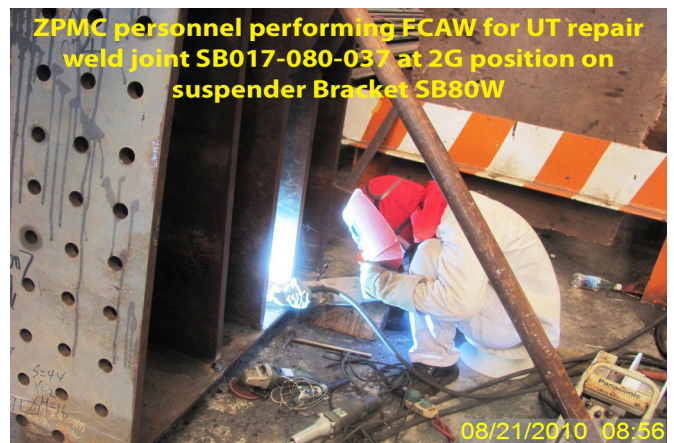
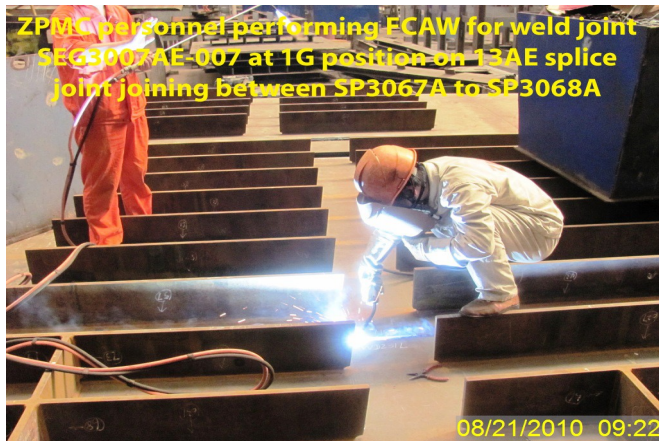
FCAW in the 4F position for the OBG Bike path, weld No. BK004A8-010-023/024. The welder is identified as #208632. ZPMC QC is identified as Mr. Li Ming Yang . The welding variables recorded by QC appear to comply with WPS-B-T-2134.

FCAW in the 2F position for the OBG Bike path, weld No. BK004A3-010-045/046. The welder is identified as #260562. ZPMC QC is identified as Mr. Li Ming Yang . The welding variables recorded by QC appear to comply with WPS-B-T-2132.

FCAW in the 2G position for the OBG suspender Bracket UT repair , weld No. SB017-080-037 The welder is identified as #062765. ZPMC QC is identified as Mr. Xu Tao. The welding variables recorded by QC appear to comply with WPS-345-FCAW-2G(2F)-REPAIR.

FCAW in the 1G position for the OBG Segment 13AE, weld No. SEG3007AE-007. The welder is identified as #044790. ZPMC QC is identified as Mr. Wang Xu. The welding variables recorded by QC appear to comply with WPS-B-T-2231-B-U2-F.

SAW in the 1G position for the OBG Segment 13AW, weld No. SEG3013AE-003. The welder is identified as #045270. ZPMC QC is identified as Mr. Zhang Ling. The welding variables recorded by QC appear to comply with WPS-B-T-2221-B-L2c-S-2.

SMAW in the 4F position for the OBG Segment 12CW, weld No. OBW12C-004/005. The welder is identified as #067572. ZPMC QC is identified as Mr. Wang Wai Ming. The welding variables recorded by QC appear to comply with WPS-B-P-2114-fcm-1.

During random in process inspection the QA inspector observed that the ZPMC personnel were performing machining at back side of the bottom plate for segment 13AE. The thickness of the bottom plate is 100 mm. The plate number is identified as BP3032A.

This QA Inspector performed Ultrasonic testing (UT) 10% of the area previously tested and accepted by ZPMC Quality control personnel. This QA inspector generated a (UT) report for this date. The member is identified as splice joint joining between side plate to side Plate for segment 9CW and 9DW at counter weight side. This Inspection was performed after ABF UT Inspectors performed UT of this joint. The result was recorded onto a data sheet according to rejection criteria of "D" Scan procedure that Caltrans QA and ABF QA have jointly filled out on this date. The QA inspector found no rejectable indication at scanned area.
